Confidential Inspection Report

LOCATED AT:
Sample Address
Sample City, MI

INSPECTED ON:
Thursday, March 3, 2022

Inspector, Tim Decker
Magnify Property Inspections LLC

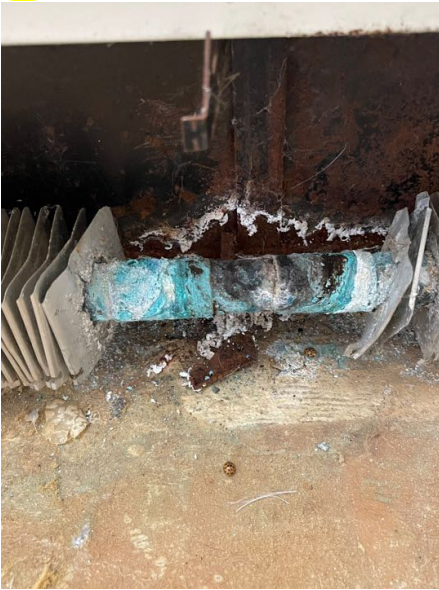
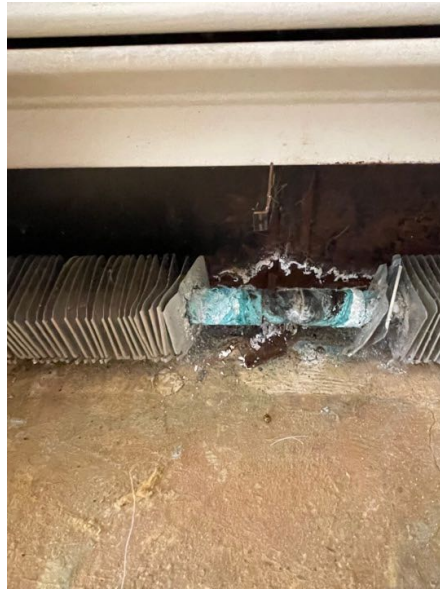
HW BASEBOARDS

WARN Several baseboard units in the basement are leaking. We recommend they be repaired or replaced.

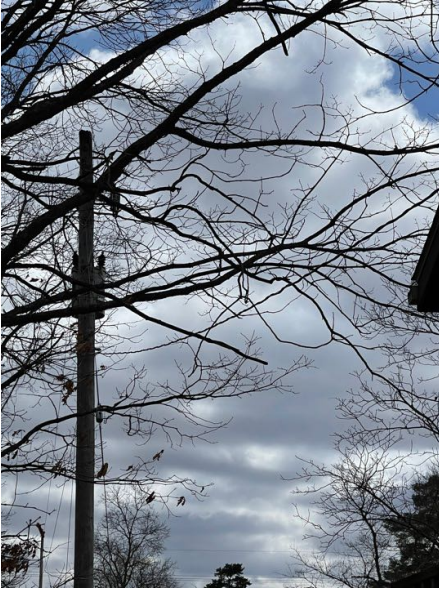
UPG The overhead service wires are deflected by trees. We recommend the trees be trimmed clear of the wires or the service be reconfigured. To reduce shock hazard during this procedure, the work should be coordinated with the utility provider.

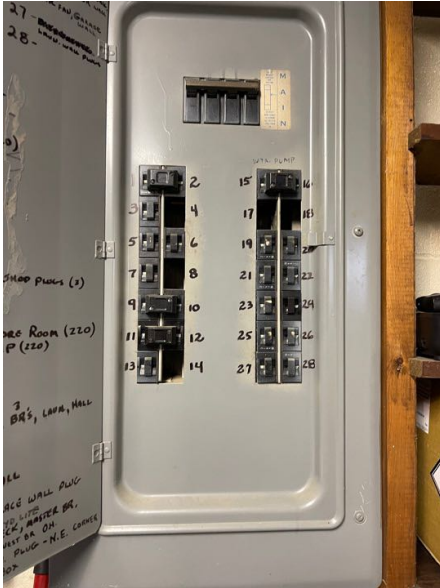
DNGR There are holes in the service panel where 'knockouts' have been removed and left open. This is not an approved practice and we recommend the holes be closed with approved filler plates.

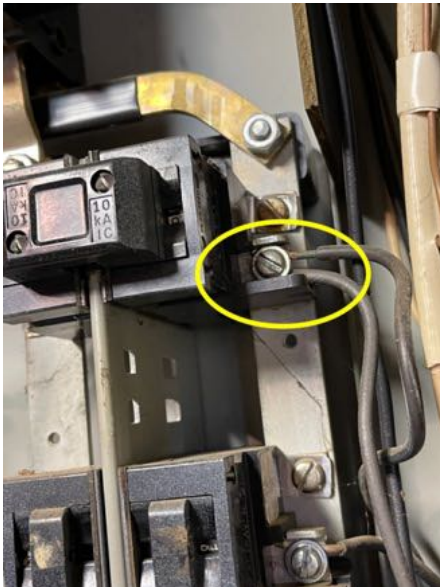
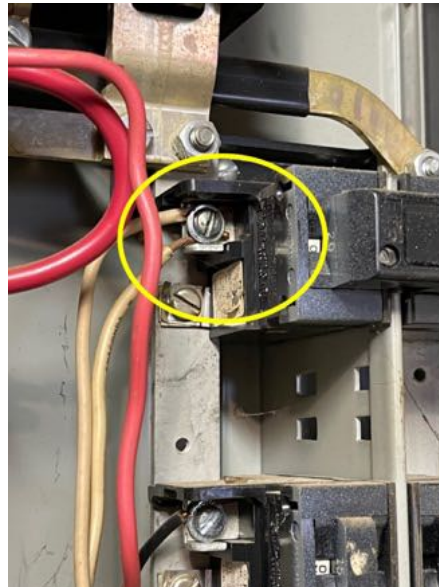
DNGR There are several double tapped breakers in the main CB panel. This is an incorrect configuration. We suggest a qualified electrician Evaluate and repair to prevent a potential hazard.

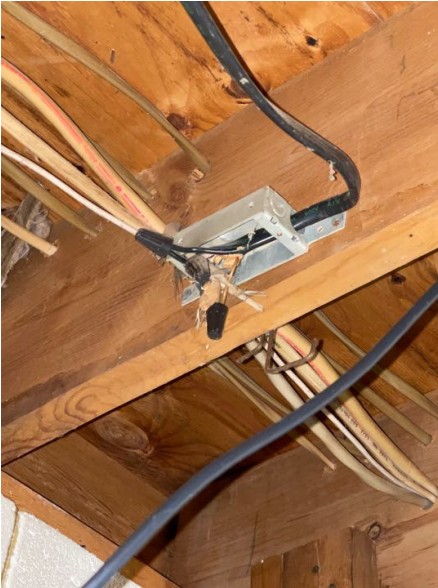
There are numerous uncovered junction boxes. We recommend these boxes be covered to protect the wiring connections.

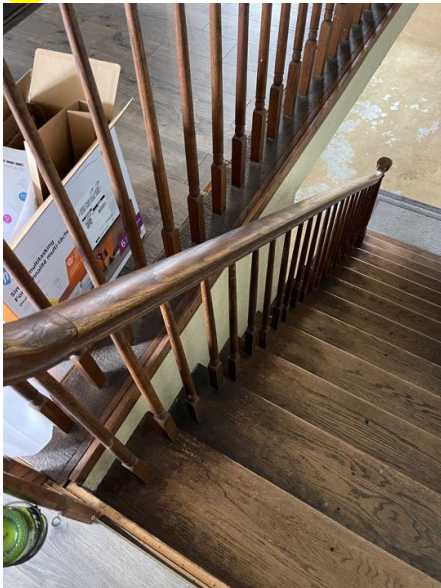
RAILINGS

WARN The railings at the upstairs steps are loose. We recommend they be repaired or replaced.

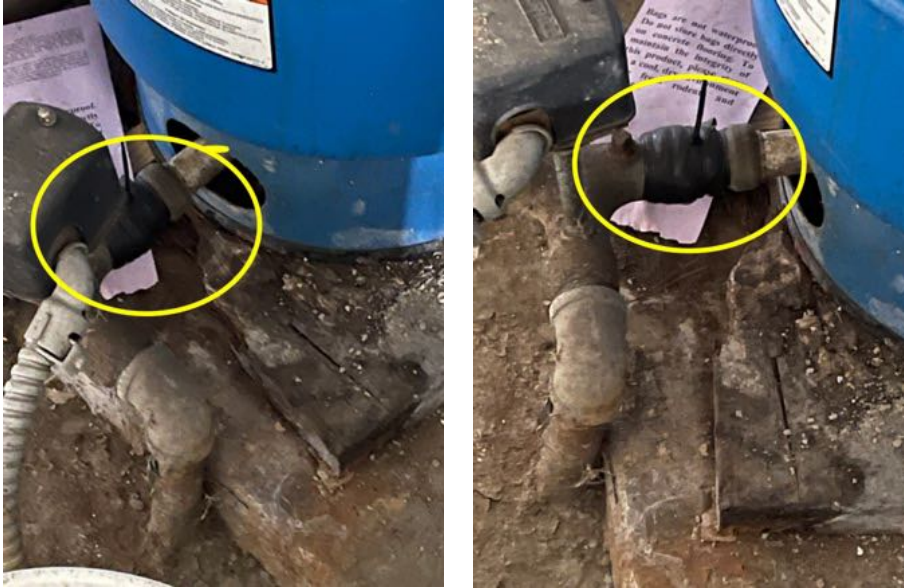
MAIN SUPPLY

WARN The main water supply line has been repaired in a substandard manner and is actively leaking. We suggest a qualified plumber evaluate and repair to prevent further leakage or damages.

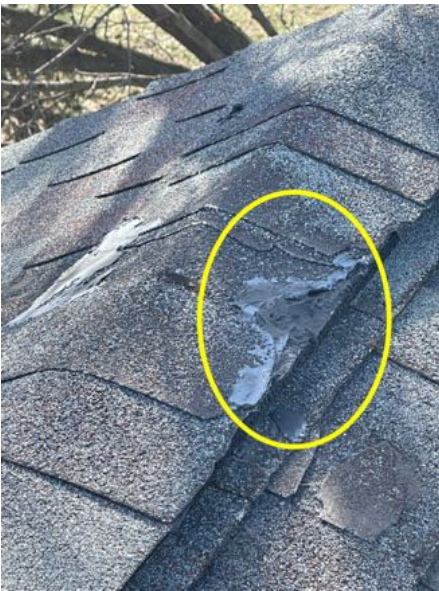
WARN The ridge shingles are damaged at the right side of the roof. We suggest a qualified roofing contractor evaluate and repair to prevent leakage or damages.

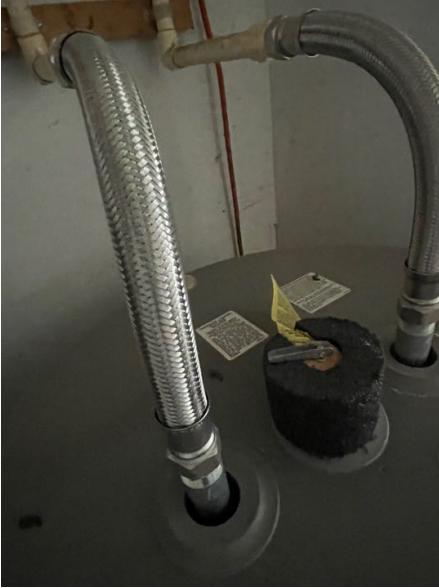
UPG The temperature and pressure relief valve lacks a discharge pipe. We recommend the installation of approved piping to an approved location.

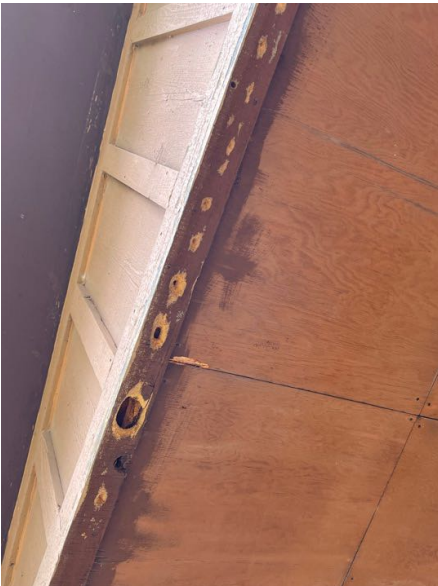
PEST CONTROL

WARN In the area near the rear, there is evidence commonly associated with wood-destroying pest and/or organism activity. We recommend consultation with a licensed pest control operator.

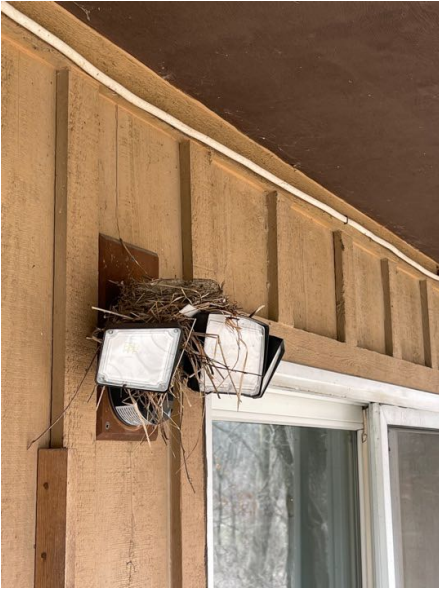
UPG There are several birds nests built against the structure at the front. We suggest removal of the nests.

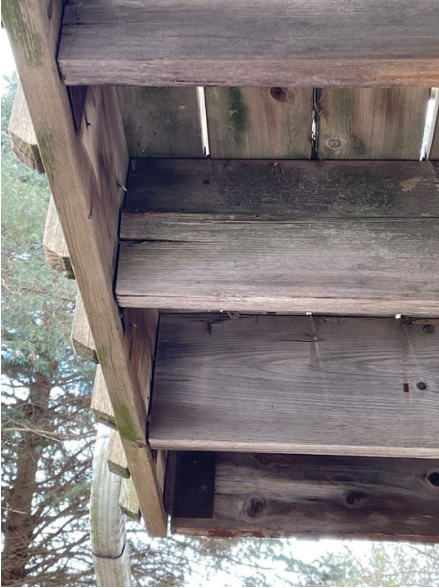
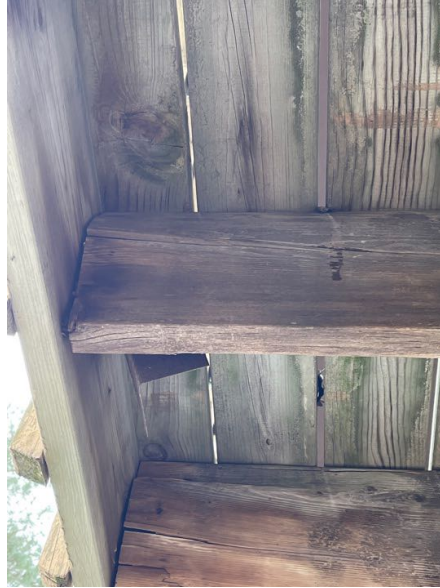
DECK SUPPORTS

UPG The balcony floor joists are damaged/deteriorated in several areas. We suggest a qualified contractor evaluate and repair to prevent further damages.

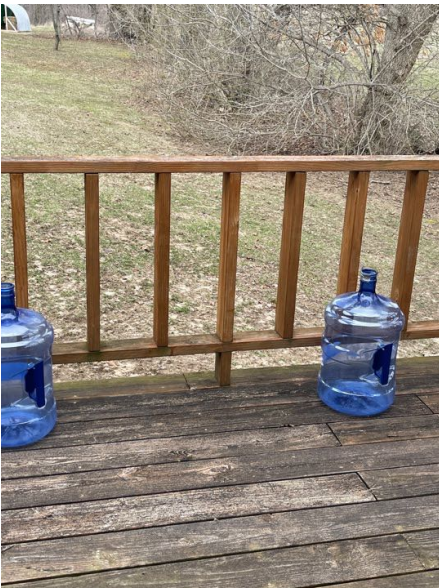
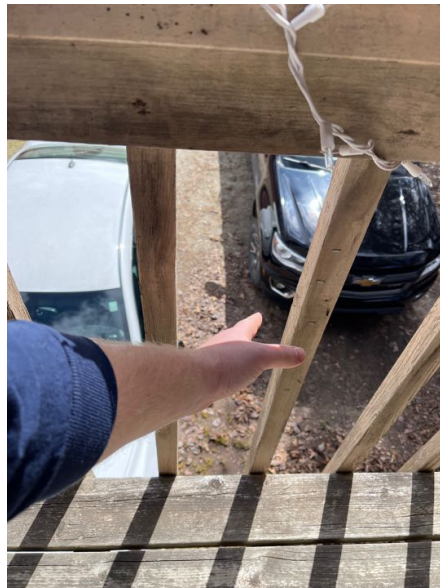
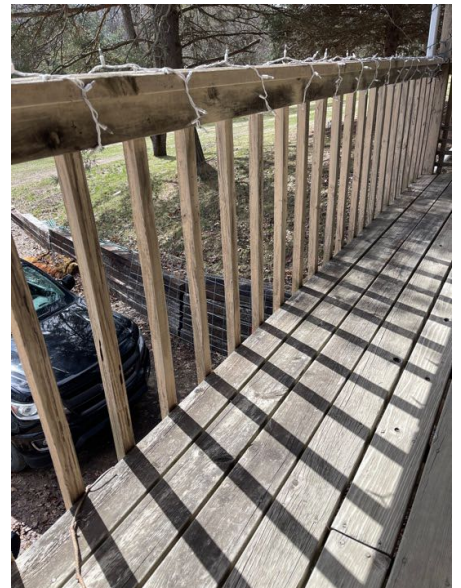
RAILINGS

WARN At the front and rear, the railing construction is deficient by present standards. Modifications to eliminate hazards, especially for children, are recommended as an upgrade. The local building authority can supply minimum present standards.

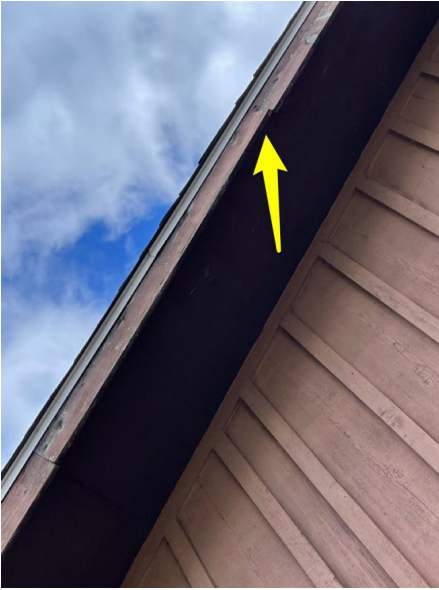
FASCIA

Sections of the fascia at the right side are damaged. We recommend they be repaired or replaced.

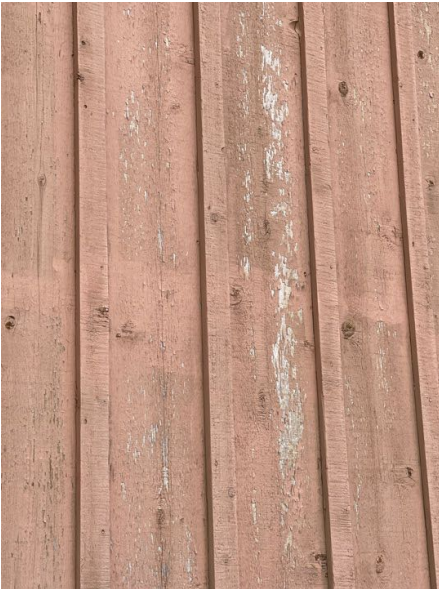
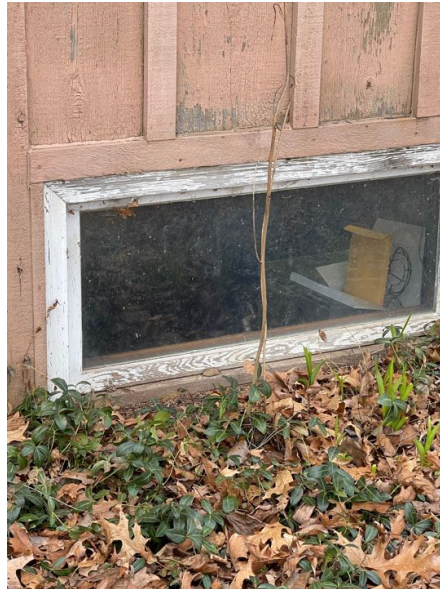
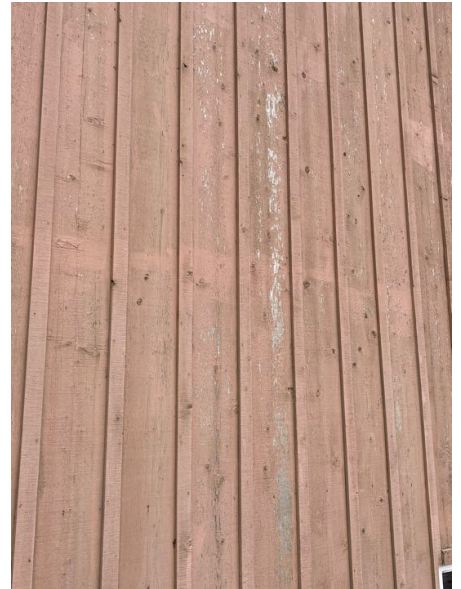
PAINT/STAIN

There is peeling paint around the exterior walls and window frames. We recommend this area be prepared and refinished.

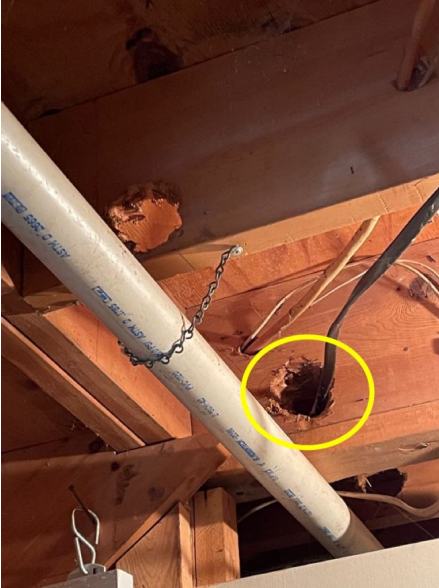
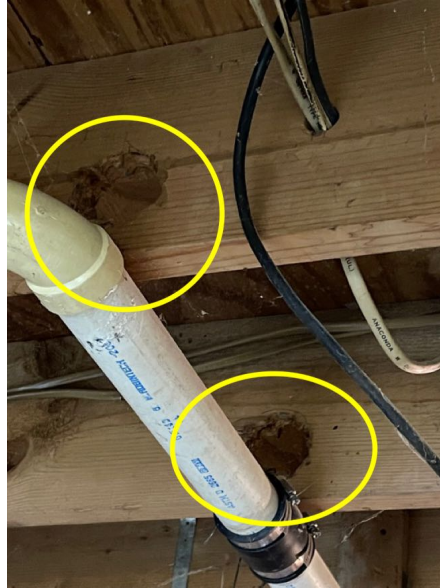
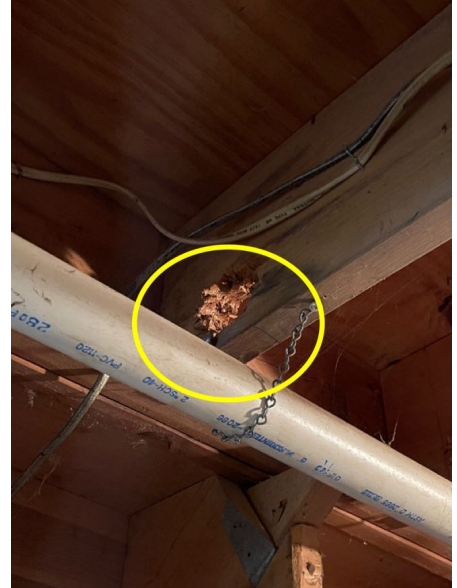
FLOOR JOISTS

WARN There is excessive notching in the floor framing near the back storage room. This has weakened the framing and we recommend repair or modification to conform to accepted standards.

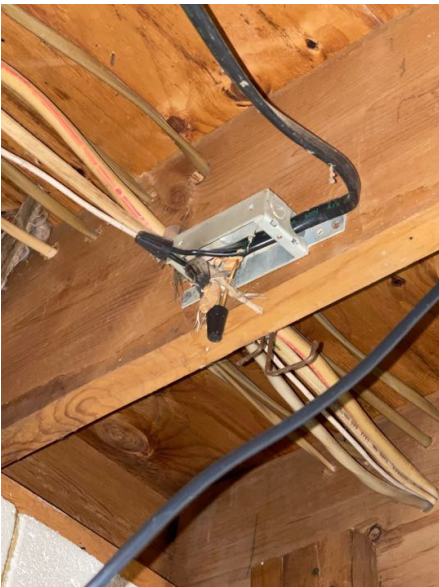
WIRING

There are uncovered junction boxes. We recommend they be covered to protect the wiring connections.

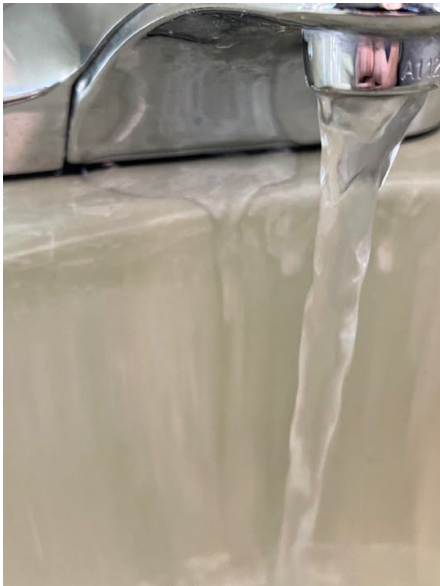
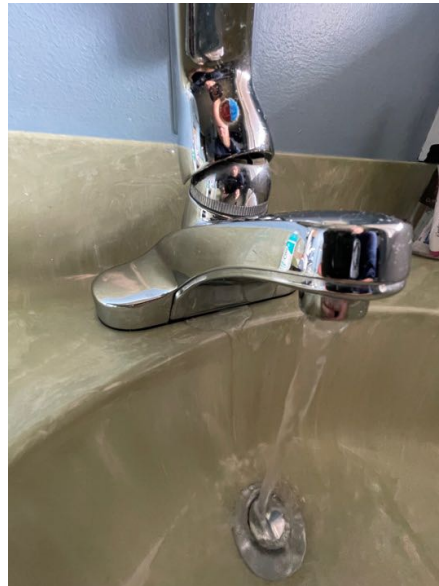
FIXTURES

WARN The bathroom faucet is leaking from the base of the handle. We recommend that it be repaired or replaced to prevent further leakage or damages.

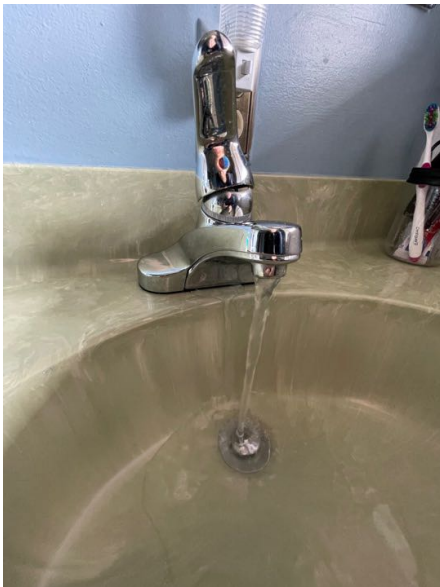
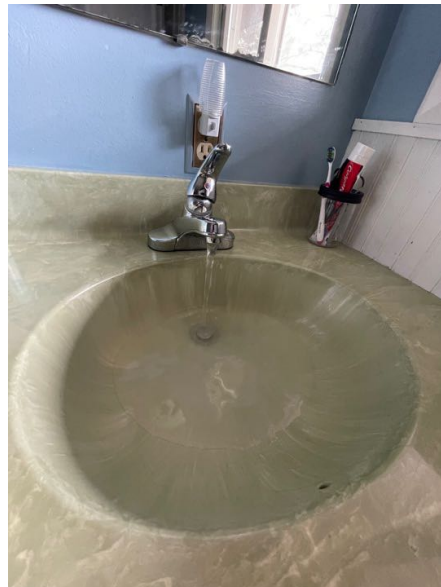
WATER BASIN

The drain is slow. We recommend the trap be cleaned of hair, sludge, etc. and if this does not correct the problem, we recommend the line be 'snaked' by a professional sewer cleaning service.

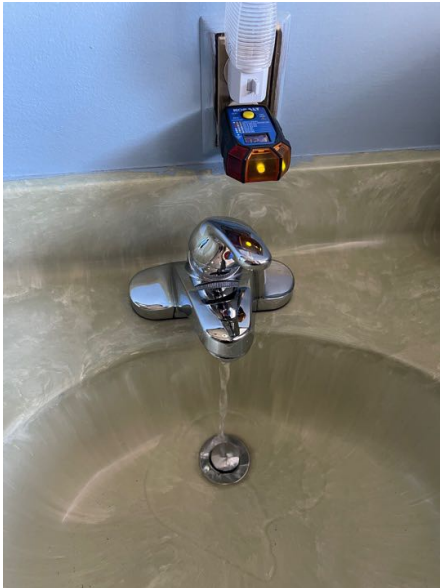
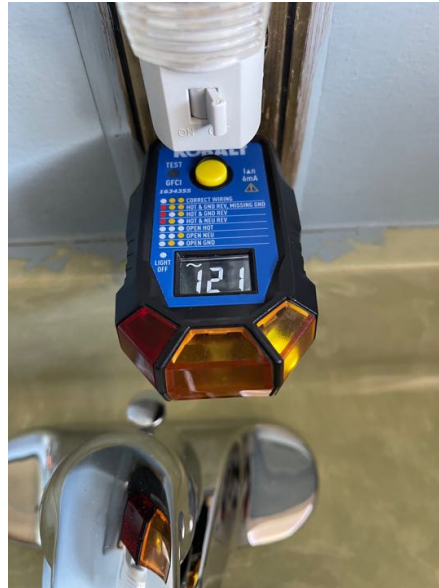
WARN There is no GFCI (ground fault circuit interrupter) protection for this bathroom. For an increased margin of safety, we recommend the installation of a GFCI receptacle.

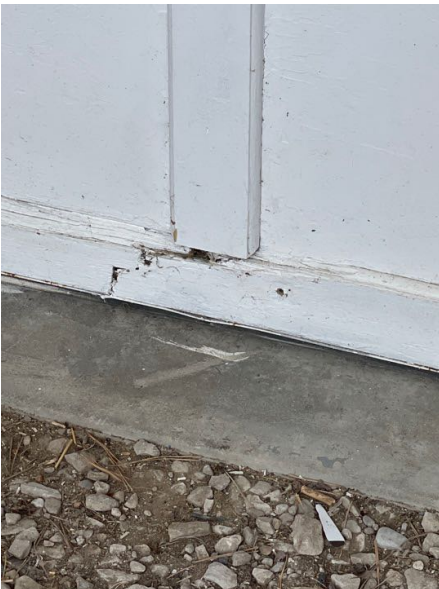
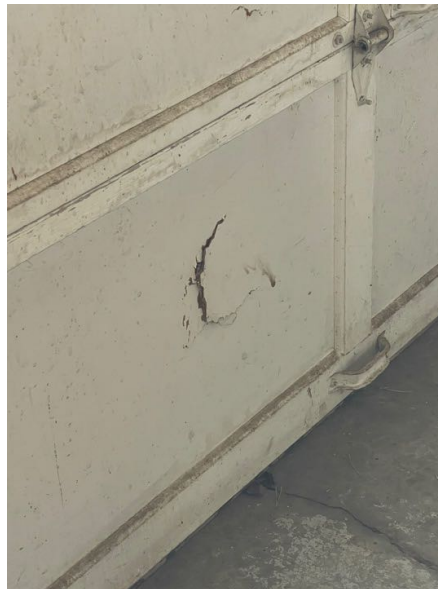
The garage door is damaged. We recommend it be repaired or replaced.

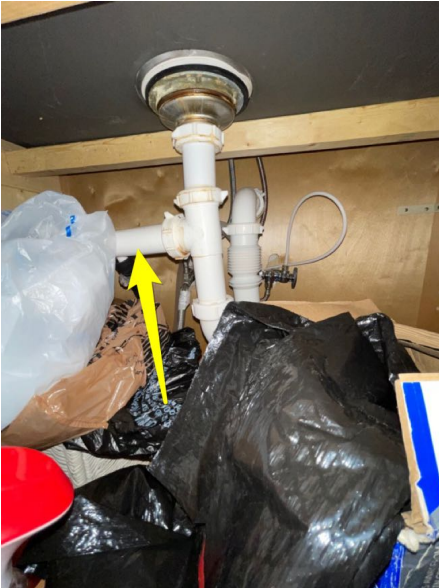
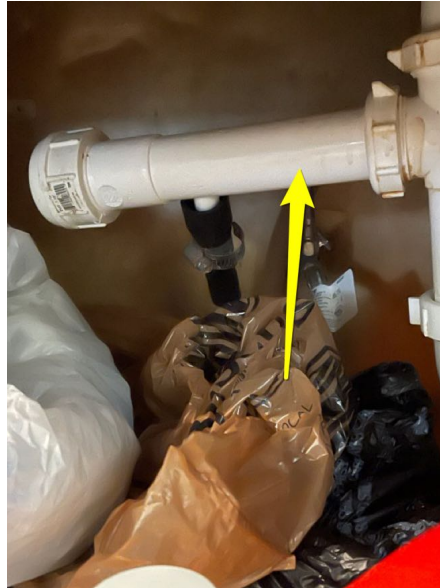
UPG The drain trap has been installed in a substandard manner. We recommend it be repaired or replaced.

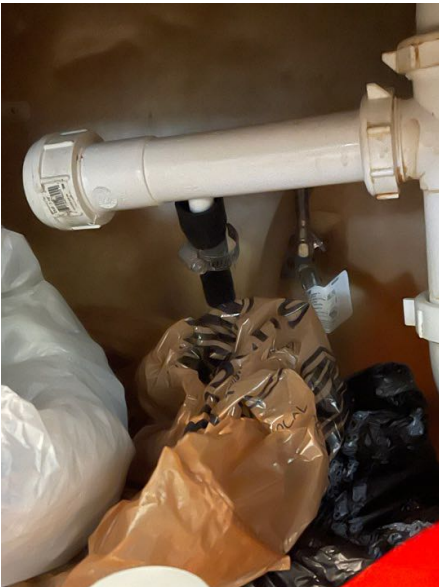
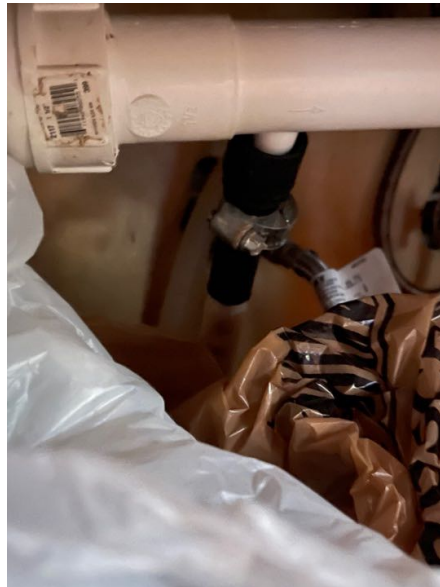
AIR GAP

UPG The dishwasher drain has no air-gap. The dishwasher will function without it, but the installation does not meet present standards. We suggest installation of an air-gap at the time the dishwasher is replaced or other plumbing work is undertaken.

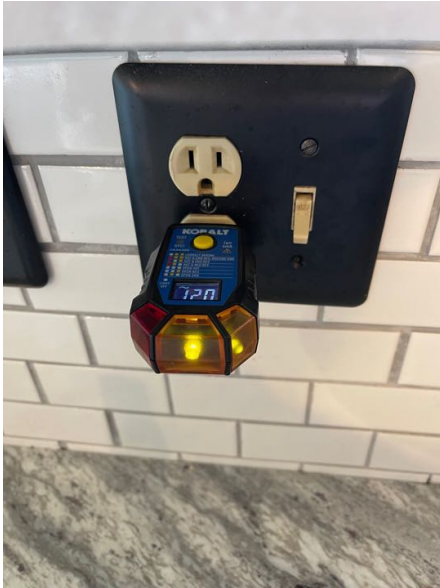
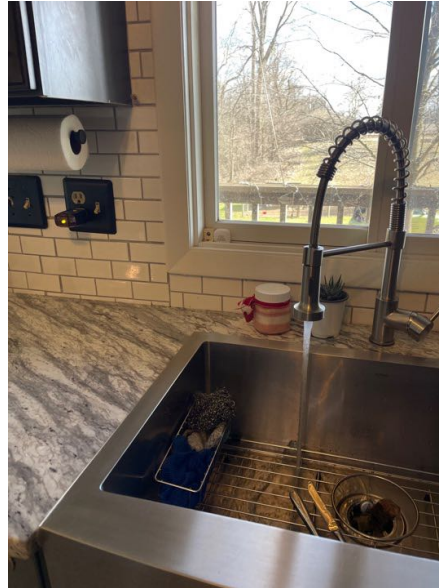
There is no GFCI (ground fault circuit interrupter) protection for the countertop receptacle(s) within six feet of the sink. For an increased margin of safety, we recommend the installation of a GFCI receptacle(s).
