Confidential Inspection Report

LOCATED AT:
Sample Address
Sample City, MI

INSPECTED ON:
Thursday, March 3, 2022

Inspector, Tim Decker
Magnify Property Inspections LLC

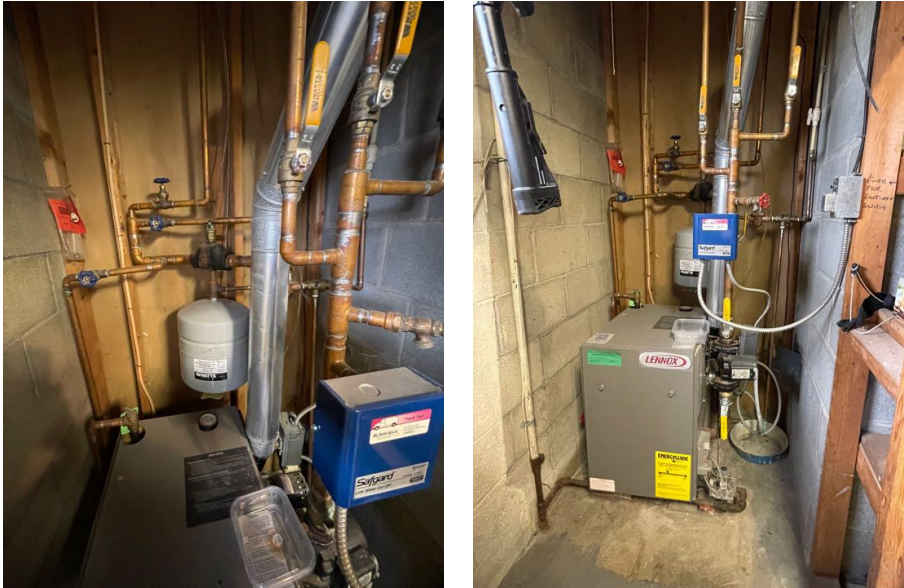
BOILER

The boiler appears to be properly installed and in serviceable condition.

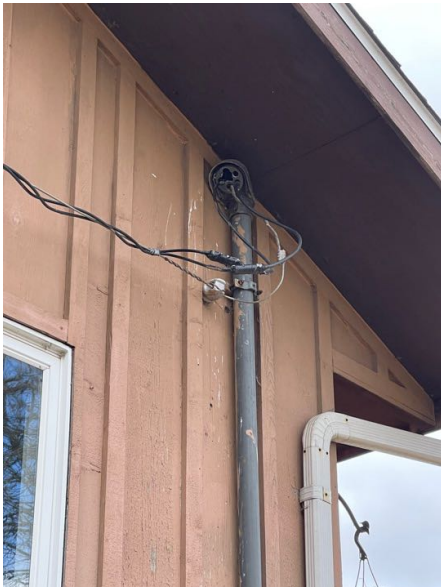
SERVICE DROP

The service drop appears to be properly installed and in good condition.

UPG The overhead service wires are deflected by trees. We recommend the trees be trimmed clear of the wires or the service be reconfigured. To reduce shock hazard during this procedure, the work should be coordinated with the utility provider.

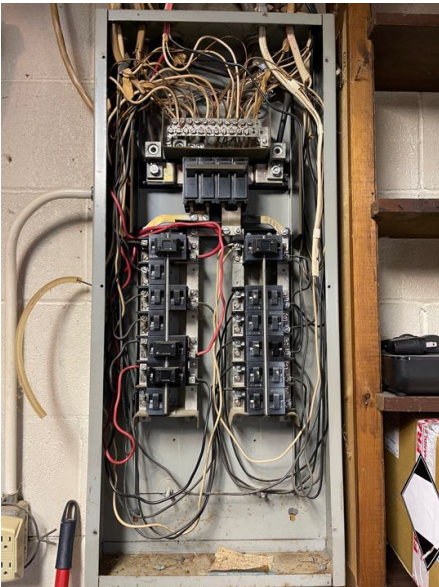
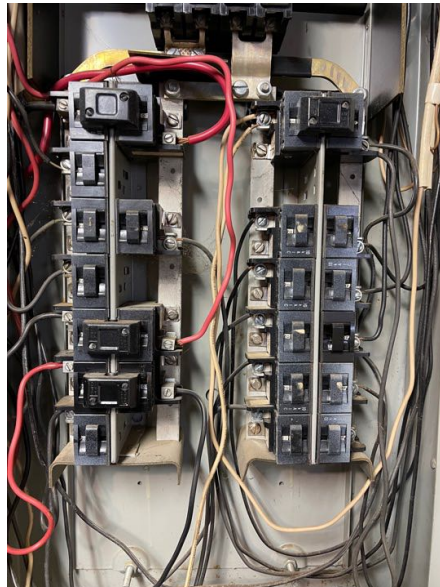
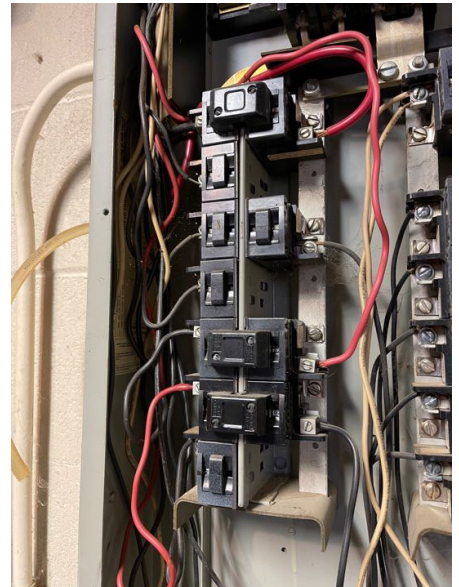
CB MAIN PANEL

UPG The main service panel does not meet present standards. However, the circuitry is generally installed and fused correctly, with only minor items worthy of attention.

DNGR There are holes in the service panel where 'knockouts' have been removed and left open. This is not an approved practice and we recommend the holes be closed with approved filler plates.

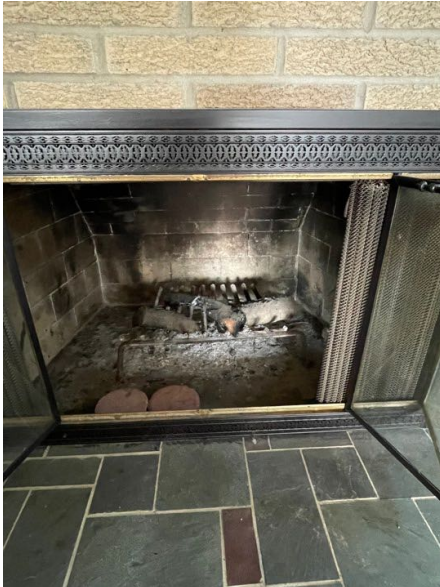
FIREPLACE

The fireplace appears to be properly installed and in serviceable condition with no signs of excessive or unusual wear.

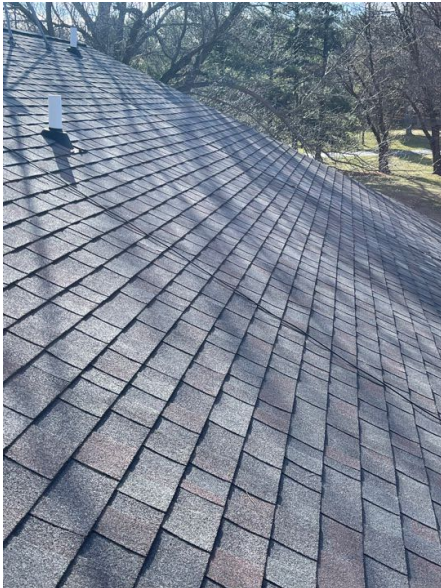
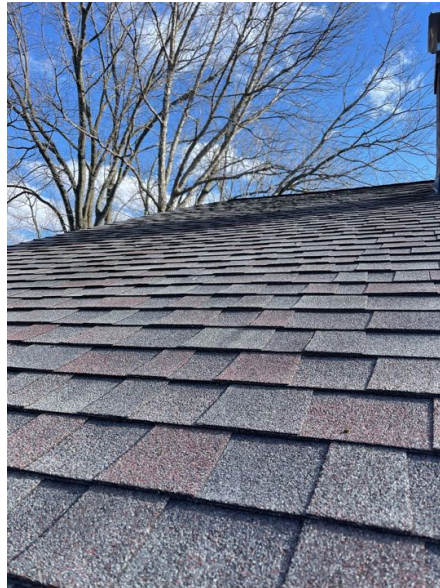
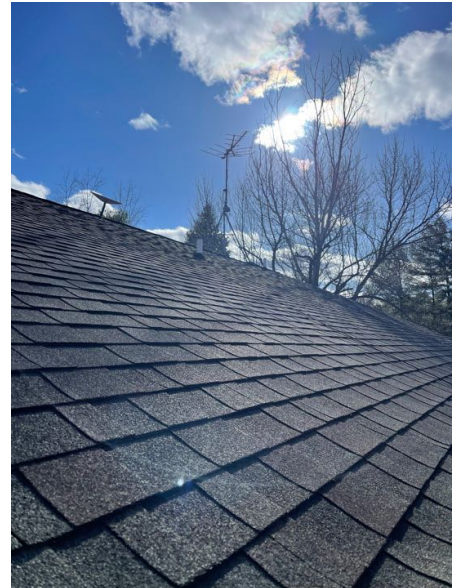
SURFACE

The roofing surface appears to have been properly installed and is in serviceable condition, with exceptions noted below. Attention to the items listed, together with routine maintenance, will keep it functional and maximize its useful life.

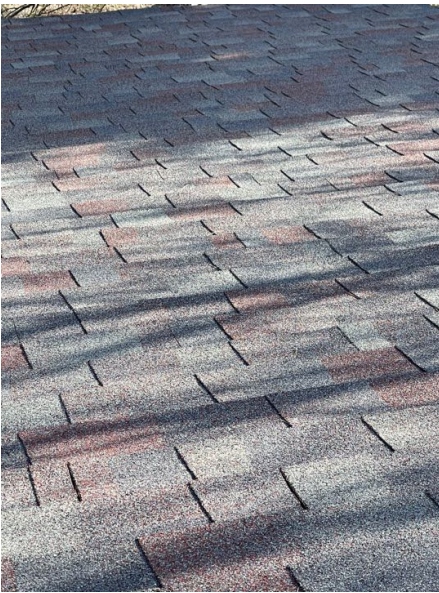
WARN 4: The ridge shingles are damaged at the right side of the roof. We suggest a qualified roofing contractor evaluate and repair to prevent leakage or damages.

WARN The ridge shingles are damaged at the right side of the roof. We suggest a qualified roofing contractor evaluate and repair to prevent leakage or damages.

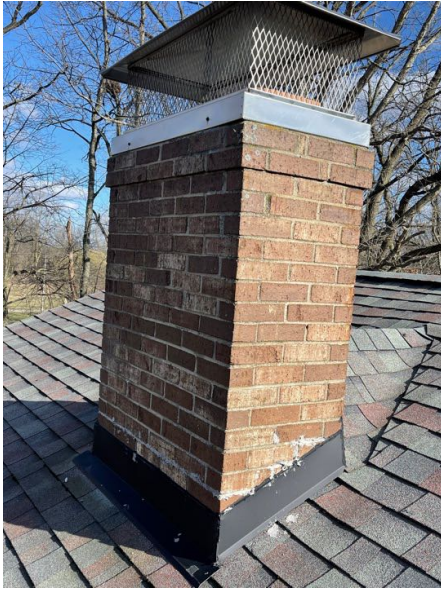
CHIMNEY AT ROOF

The chimney appears to be properly installed and in serviceable condition.

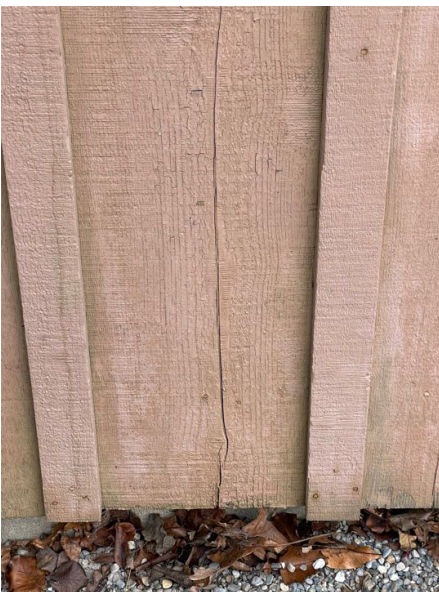
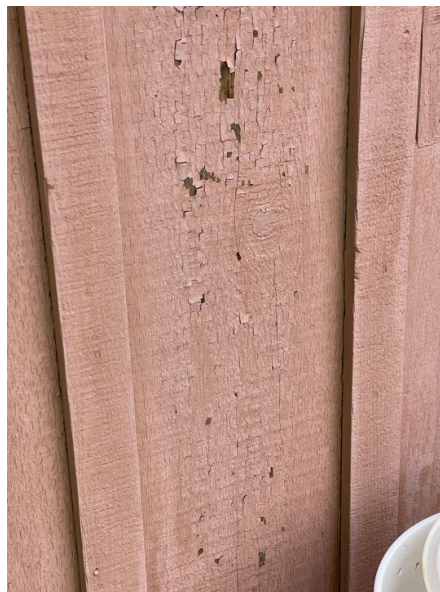
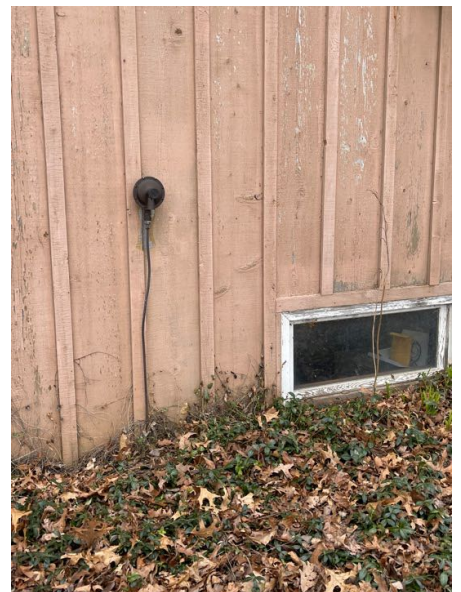
PLYWOOD SIDING

The plywood siding shows routine wear but is generally in serviceable condition. We recommend minor maintenance to ensure maximum service life.

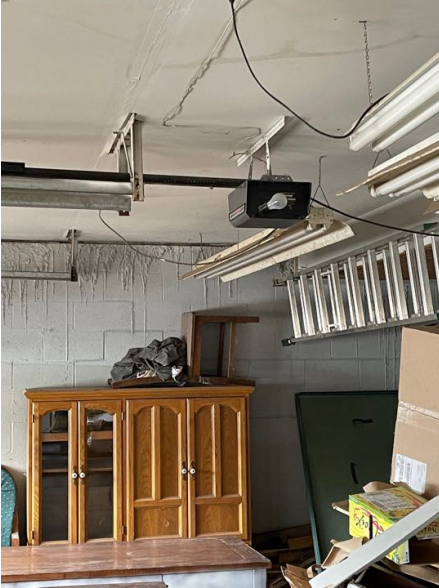
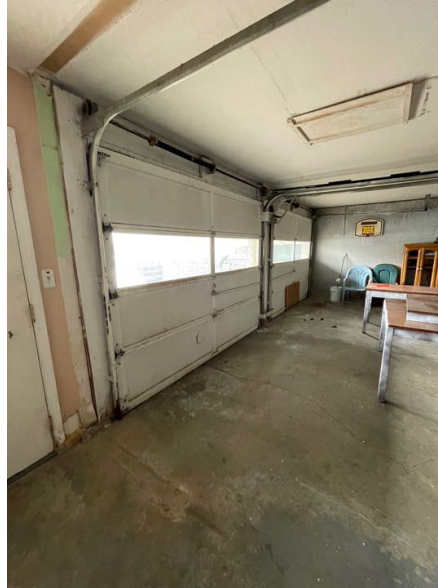
GARAGE DOOR OPENER

DNGR The garage door opener lacks electric eyes. This is an important safety feature. We suggest installation of electric eyes in this area at the base of both garage doors to ensure maximum safety.

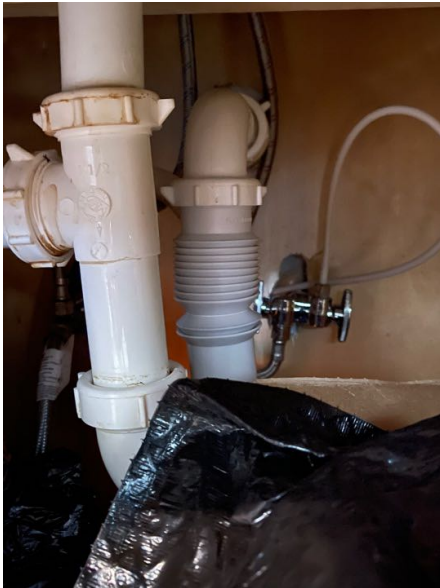
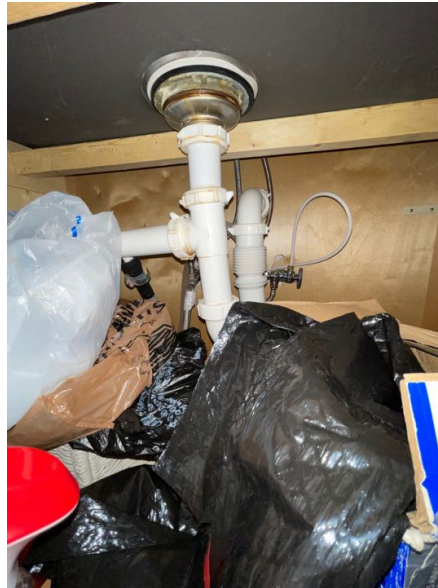
DRAIN TRAPS

The drain trap and associated piping are PVC plastic.

UPG The drain trap has been installed in a substandard manner. We recommend it be repaired or replaced.
